# Manhole Inspection Summary

Manhole # S2901\_022MH

Insp Date: **2/25/08 10:01 AM**

**Location** Address: **2718 Woodview Road**

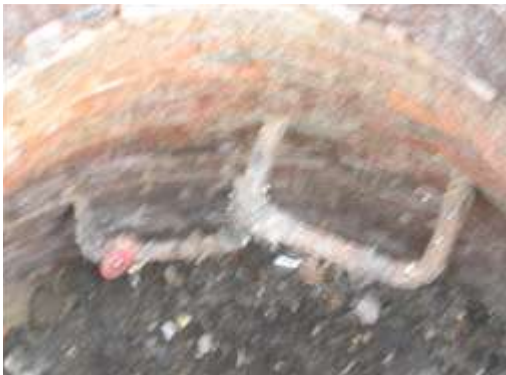
**Steps** Count: **2** Missing: **0** ☒ **Corroded**

steps

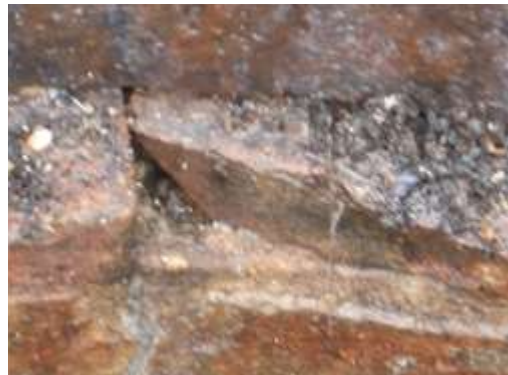
Defect 2

Condition: ☐ Sound ☐ Cracked ☐ Root Intrusion ☒ **Loose Brick** ☐ Deteriorated

loose bricks on chimney

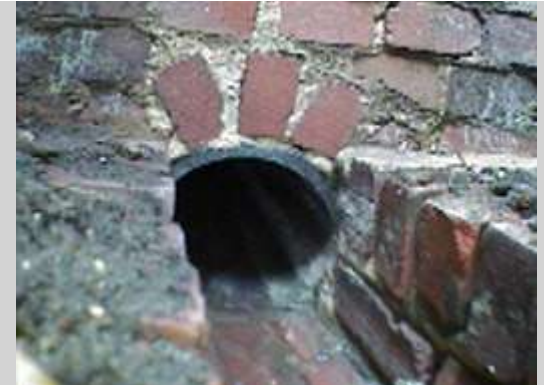
12 O'Clock Outflow

8 in. Circular Gravity Sewer  
Pipe Out @ 12 O'Clock

Pipe Height: **9.6** (in.) Rod and Bar (Angled)  
Pipe Material: **DIP/CI** ☐ Pipe Lined  
Invert Depth: **5.96** (ft.) Flow Characteristics: **Slow**  
Deposits: ☒ None ☐ Mud ☐ Sludge ☐ Debris ☐ Grease  
Silt Depth: (in.) Deposits Extent:  
Infiltration: **None** Pipe Seal Cond: **Sound**

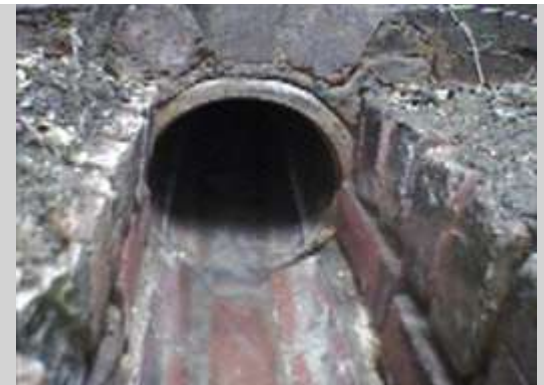
6 O'Clock Inflow

8 in. Circular Gravity Sewer  
Pipe In @ 6 O'Clock

Pipe Height: **8.4** (in.) Rod and Bar (Angled)  
Pipe Material: **Clay** ☐ Pipe Lined  
Invert Depth: **5.56** (ft.) Flow Characteristics: **Slow**  
Deposits: ☒ None ☐ Mud ☐ Sludge ☐ Debris ☐ Grease  
Silt Depth: (in.) Deposits Extent:  
Infiltration: **None** Pipe Seal Cond: **Sound**
